# ANNUAL REPORT FOR 2011

**Unnamed Tributary to Lumber  
River Mitigation Site  
Robeson County  
TIP No. R-0513WM**

Prepared By:  
Natural Environment Unit & Roadside Environmental Unit  
North Carolina Department of Transportation  
September 2011

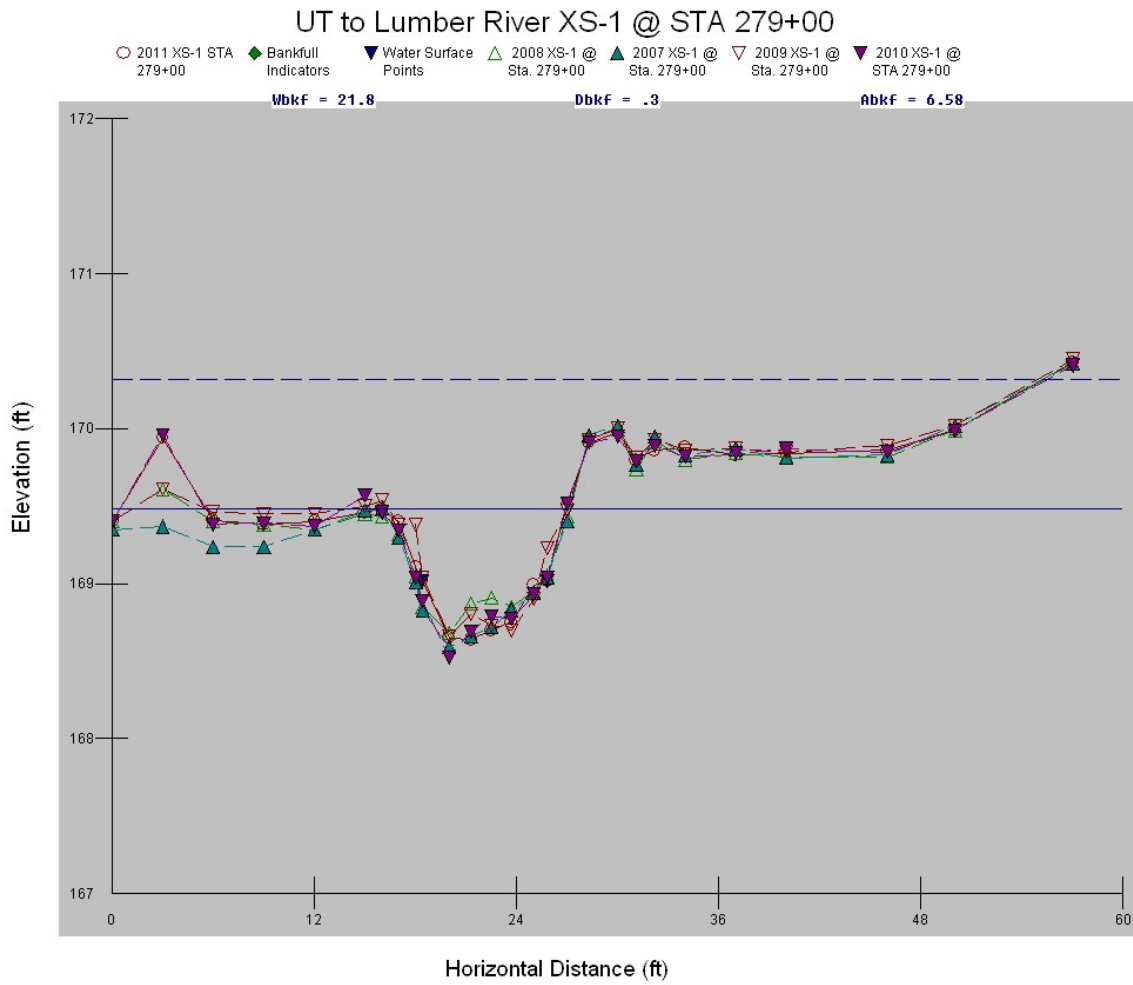
Based on comparisons of the monitoring data, all eleven cross sections appear stable with little or no active bank erosion. Graphs of the cross sections are presented in Appendix A. Future survey data will vary depending on actual location of rod placement and alignment; however this information should remain similar in appearance.

Cross-Section #1 (Riffle) Abbreviated Morphological Summary					
	2008	2009	2010	2011	2012
Bankfull Width (ft)	11.0	11.20	10.90	10.93	
Bankfull Mean Depth (ft)	0.45	0.54	0.55	0.54	
Width/Depth Ratio	24.44	20.74	19.73	20.24	
Bankfull Cross Sectional Area (ft <sup>2</sup> )	4.98	6.03	5.92	5.86	
Maximum Bankfull Depth (ft)	0.75	0.88	0.94	0.84	
Width of the Floodprone Area (ft)	53	56	56.83	55.25	
Entrenchment Ratio	4.83	5.05	5.24	5.06

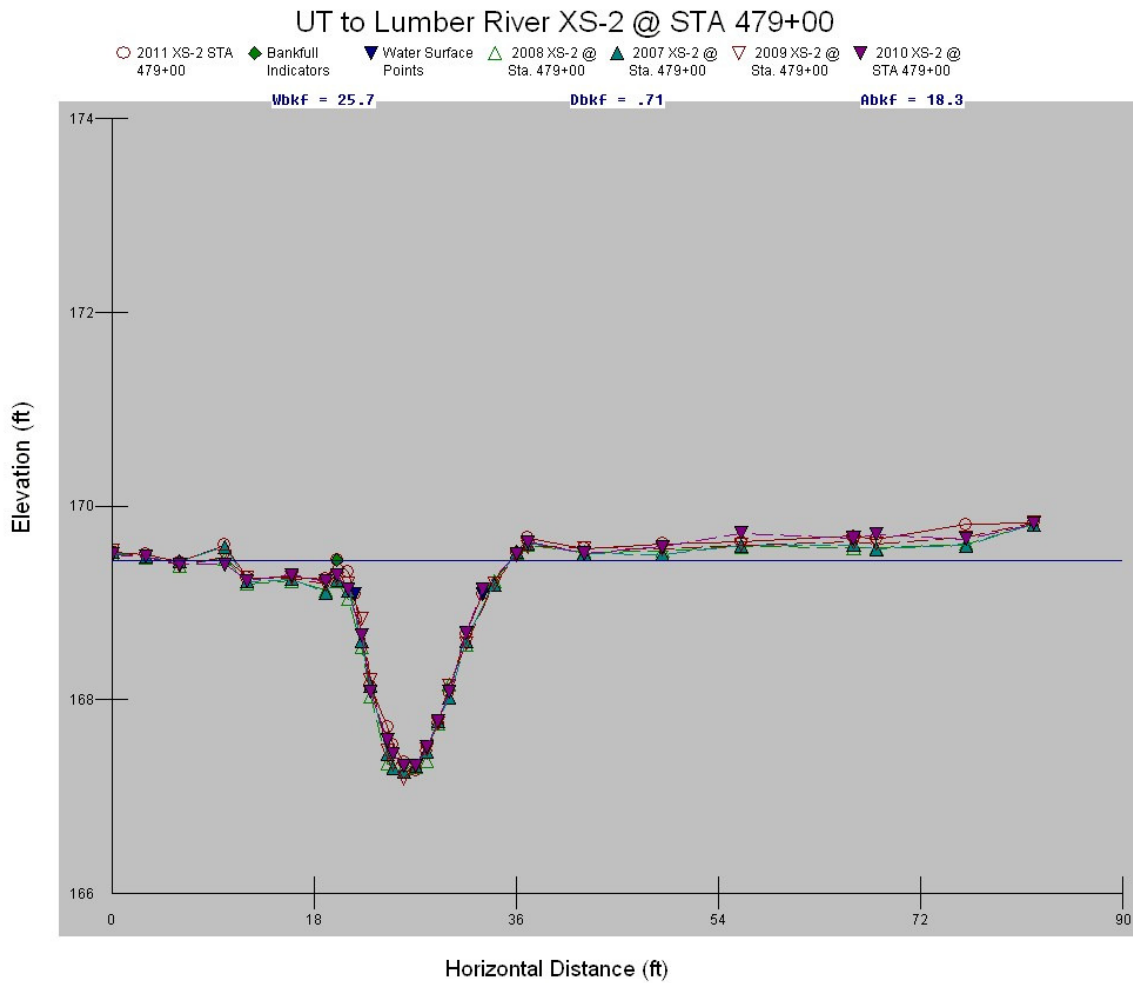
Cross-Section #2 (Pool) Abbreviated Morphological Summary*					
	2008	2009	2010	2011	2012
Bankfull Cross Sectional Area (ft <sup>2</sup> )	15.31	15.05	15.12	16.89	
Maximum Bankfull Depth (ft)	1.92	2.06	1.97	2.17	
Bankfull Mean Depth (ft)	1.09	0.84	1.06	1.09	
Bankfull Width (ft)	14.0	17.92	14.25	15.44

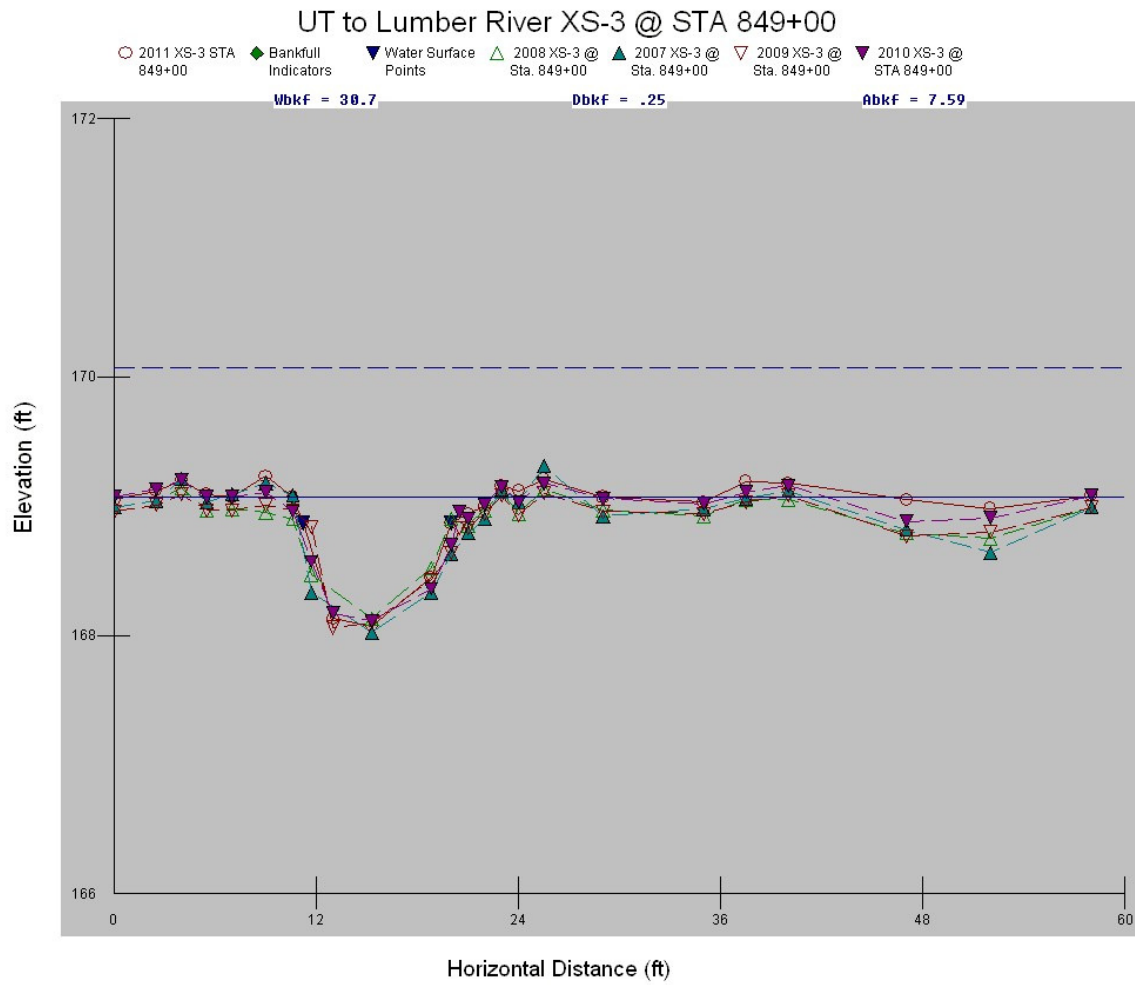
Cross-Section #3 (Riffle) Abbreviated Morphological Summary					
	2008	2009	2010	2011	2012
Bankfull Width (ft)	9.4	11.40	13.71	11.4	
Bankfull Mean Depth (ft)	0.49	0.53	0.57	0.61	
Width/Depth Ratio	19.18	21.51	24.05	18.69	
Bankfull Cross Sectional Area (ft <sup>2</sup> )	4.64	6.06	7.87	6.91	
Maximum Bankfull Depth (ft)	0.77	0.91	1.00	1	
Width of the Floodprone Area (ft)	58	58	58	58	
Entrenchment Ratio	6.17	5.09	4.23	5.09

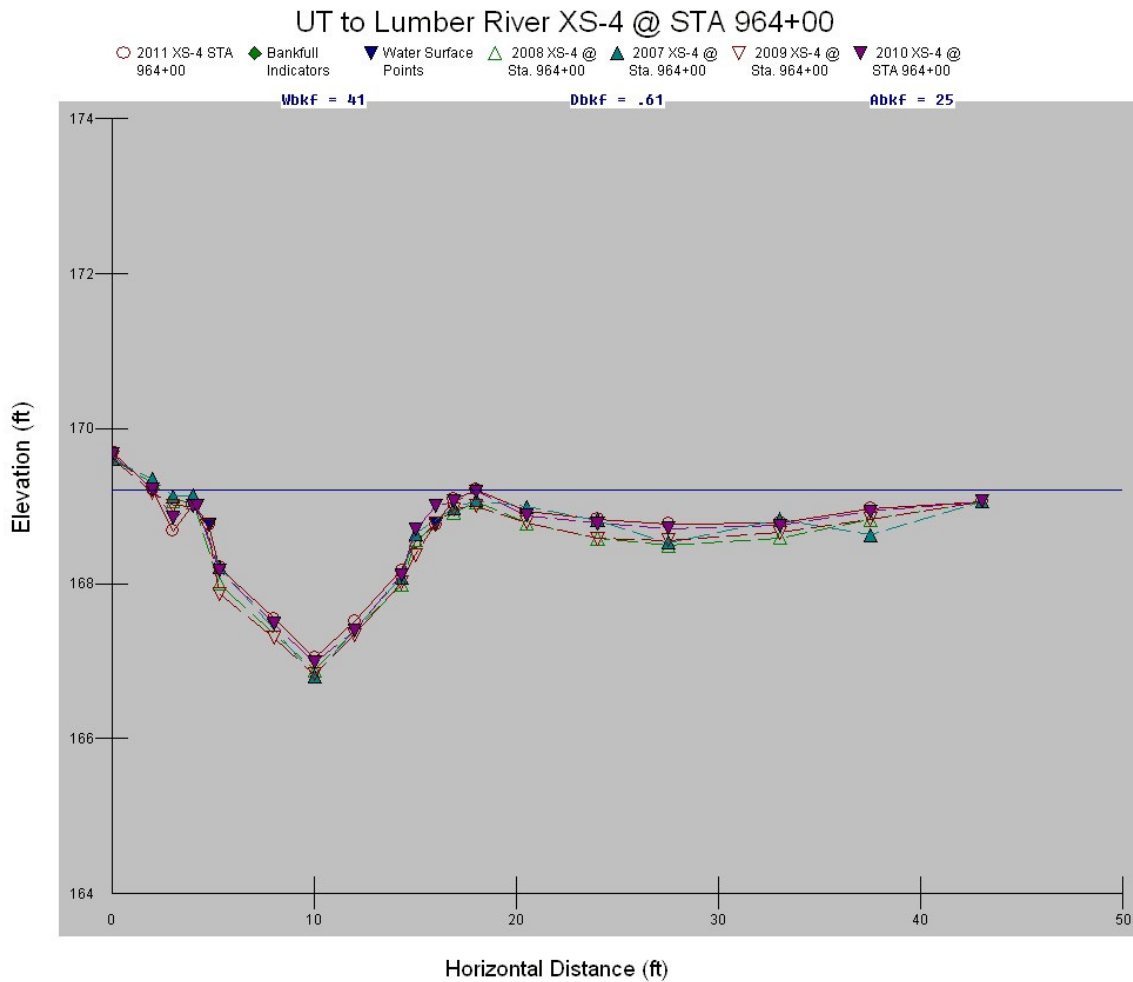
Cross-Section #4 (Pool) Abbreviated Morphological Summary*					
	2008	2009	2010	2011	2012
Bankfull Cross Sectional Area (ft <sup>2</sup> )	16.42	17.90	17.16	17.16	
Maximum Bankfull Depth (ft)	2.17	2.29	2.21	2.17	
Bankfull Mean Depth (ft)	1.17	1.28	1.08	1.07	
Bankfull Width (ft)	14.0	14.0	15.92	15.98

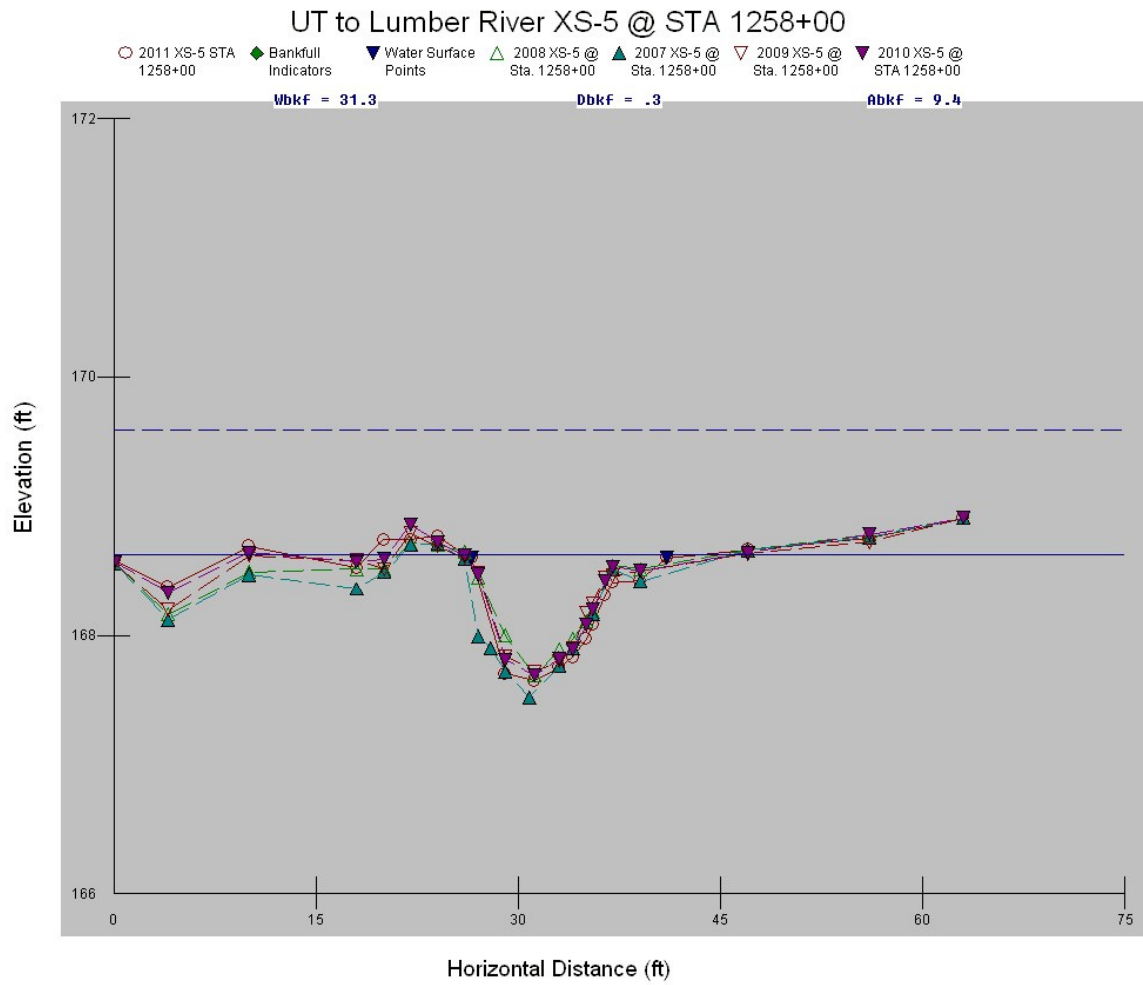
Cross-Section #5 (Riffle) Abbreviated Morphological Summary					
	2008	2009	2010	2011	2012
Bankfull Width (ft)	10.45	9.31	11.00	11.00	
Bankfull Mean Depth (ft)	0.49	0.49	0.59	0.66	
Width/Depth Ratio	21.33	19.0	18.64	16.67	
Bankfull Cross Sectional Area (ft <sup>2</sup> )	5.11	4.52	6.51	7.3	
Maximum Bankfull Depth (ft)	0.85	0.73	0.93	0.97	
Width of the Floodprone Area (ft)	63	63	63	63	
Entrenchment Ratio	6.03	6.77	5.73	5.73

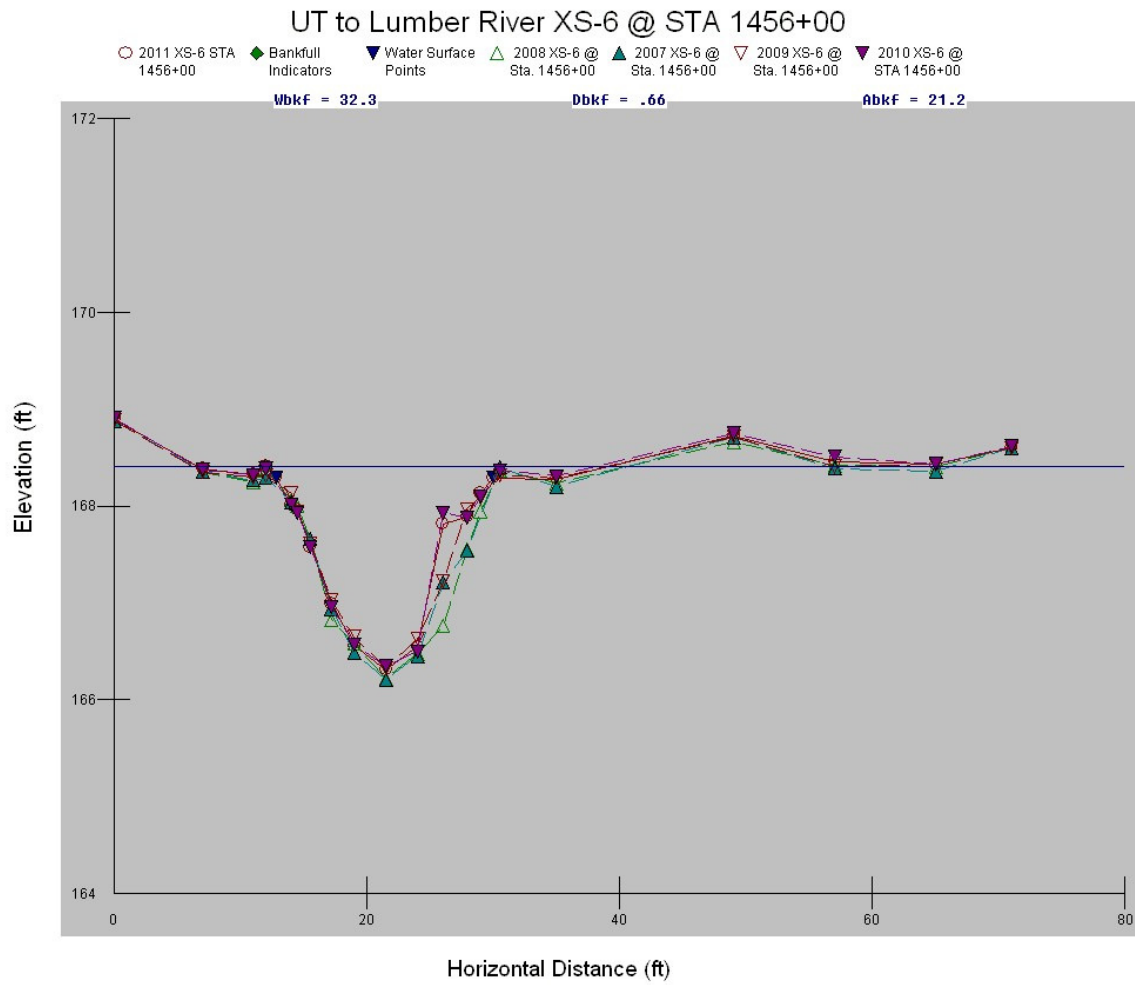
Cross-Section #6 (Pool) Abbreviated Morphological Summary*					
	2008	2009	2010	2011	2012
Bankfull Cross Sectional Area (ft <sup>2</sup> )	22.71	19.06	19.54	20.06	
Maximum Bankfull Depth (ft)	2.15	1.99	2.03	2.1	
Bankfull Mean Depth (ft)	1.23	1.03	1.06	1.07	
Bankfull Width (ft)	18.50	18.50	18.45	18

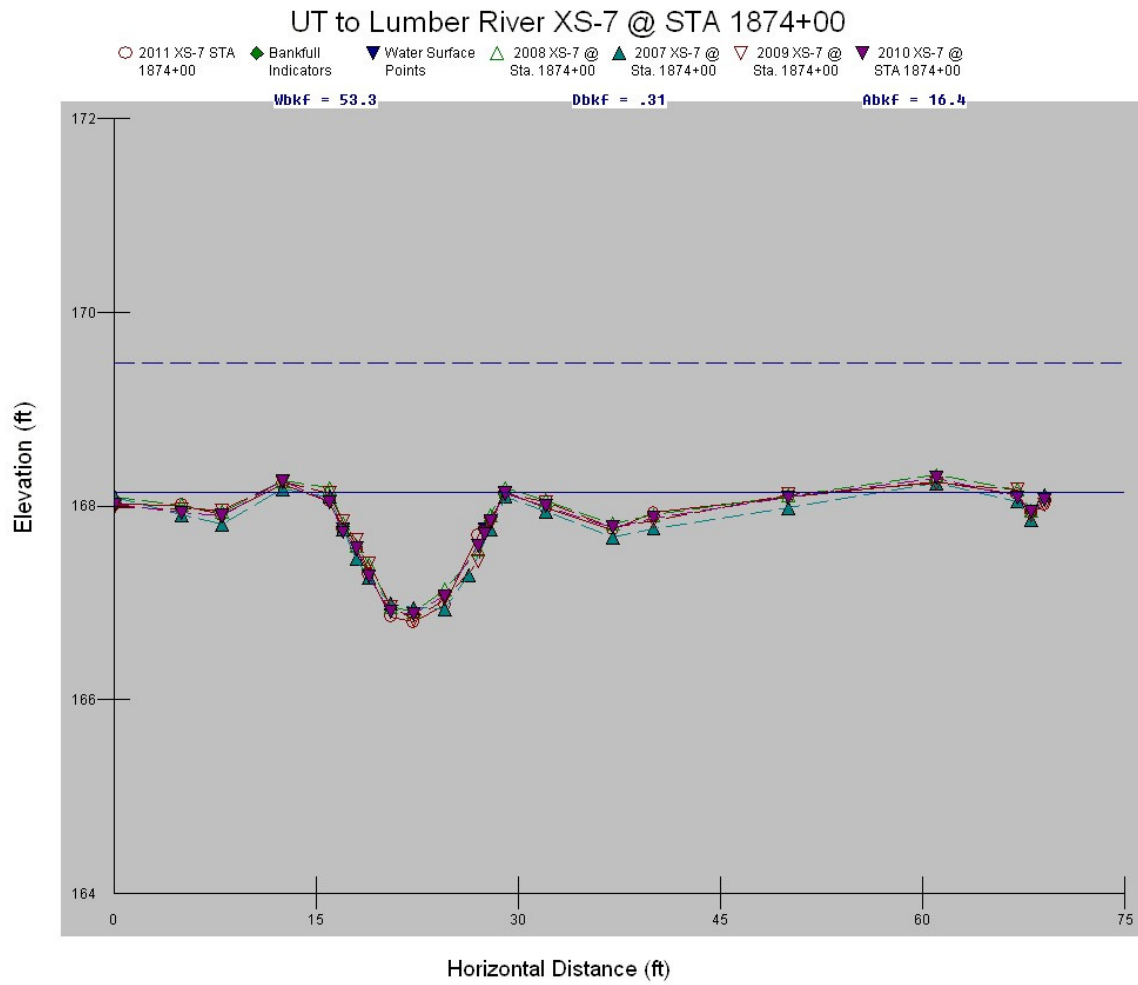
Cross-Section #7 (Riffle) Abbreviated Morphological Summary					
	2008	2009	2010	2011	2012
Bankfull Width (ft)	13.0	13.0	12.8	13	
Bankfull Mean Depth (ft)	0.8	0.79	0.75	0.82	
Width/Depth Ratio	16.25	16.46	17.07	15.85	
Bankfull Cross Sectional Area (ft <sup>2</sup> )	10.4	10.26	9.66	10.63	
Maximum Bankfull Depth (ft)	1.28	1.30	1.19	1.34	
Width of the Floodprone Area (ft)	69	69	69	69	
Entrenchment Ratio	5.31	5.31	5.39	5.31

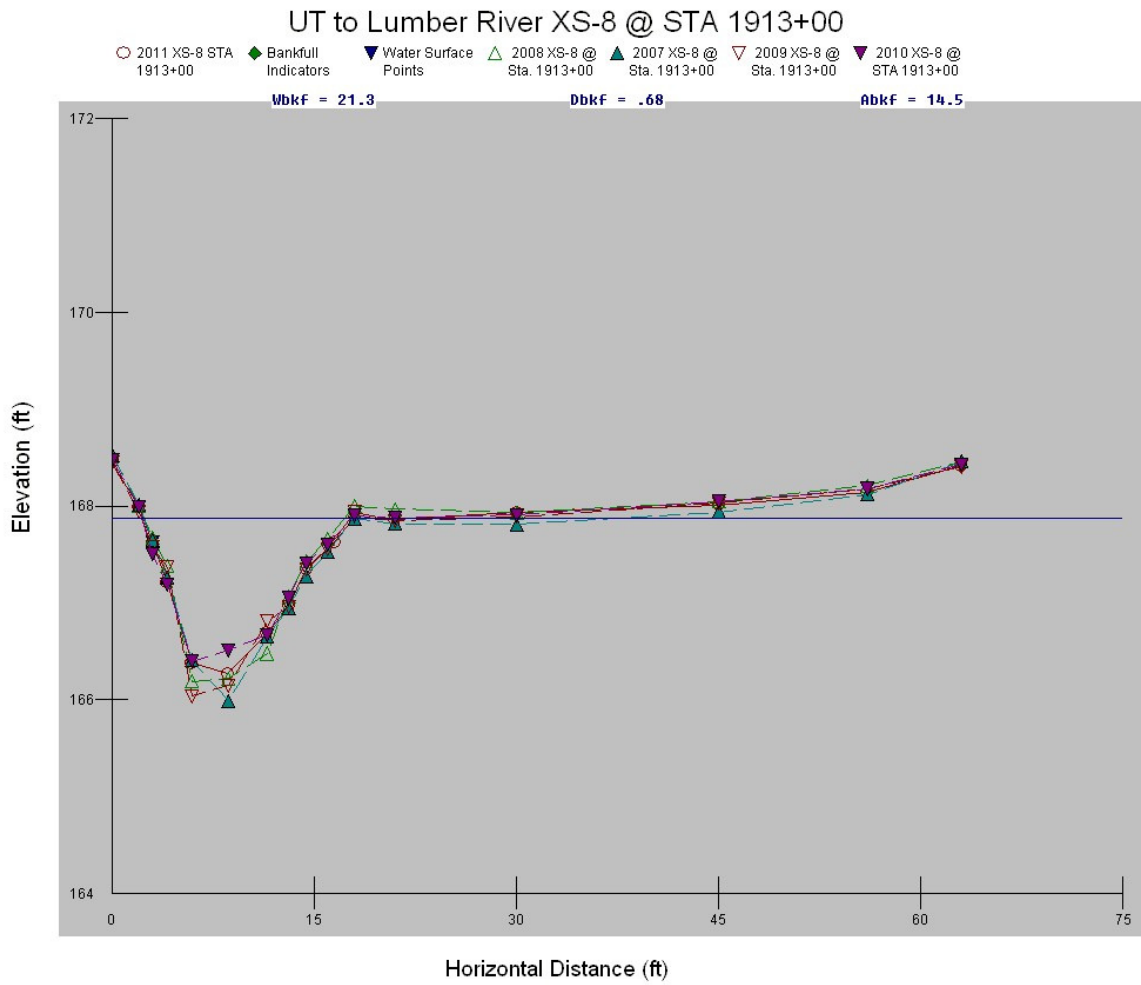
Cross-Section #8 (Pool) Abbreviated Morphological Summary*					
	2008	2009	2010	2011	2012
Bankfull Cross Sectional Area (ft <sup>2</sup> )	16.5	16.01	14.56	14.43	
Maximum Bankfull Depth (ft)	1.81	1.90	1.54	1.61	
Bankfull Mean Depth (ft)	1.03	1.0	0.92	0.92	
Bankfull Width (ft)	16	16	15.9	15.69

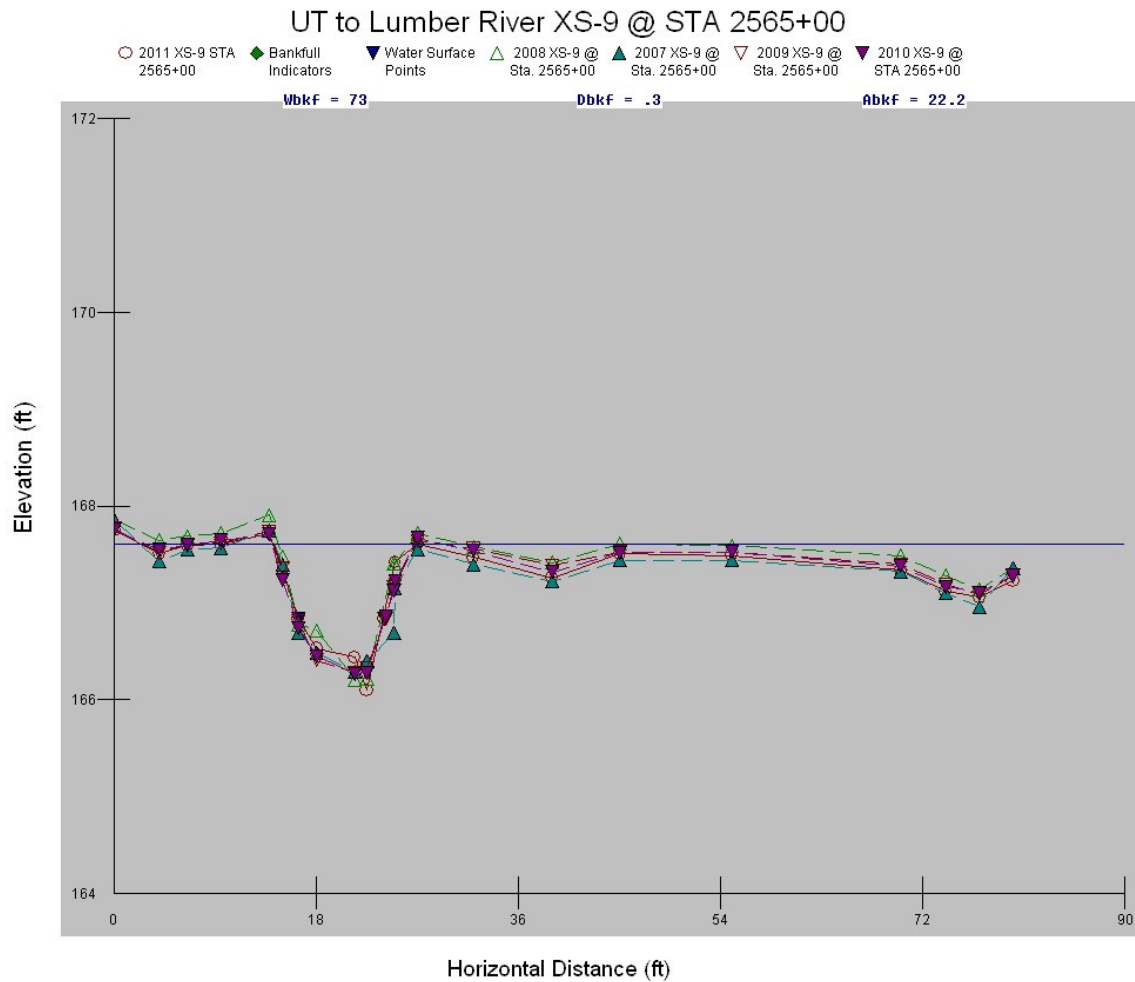
Cross-Section #9 (Pool) Abbreviated Morphological Summary*					
	2008	2009	2010	2011	2012
Bankfull Cross Sectional Area (ft <sup>2</sup> )	10.89	11.15	11.74	10.01	
Maximum Bankfull Depth (ft)	1.51	1.36	1.40	1.51	
Bankfull Mean Depth (ft)	0.86	0.87	0.90	0.78	
Bankfull Width (ft)	12.61	12.88	13.10	12.86

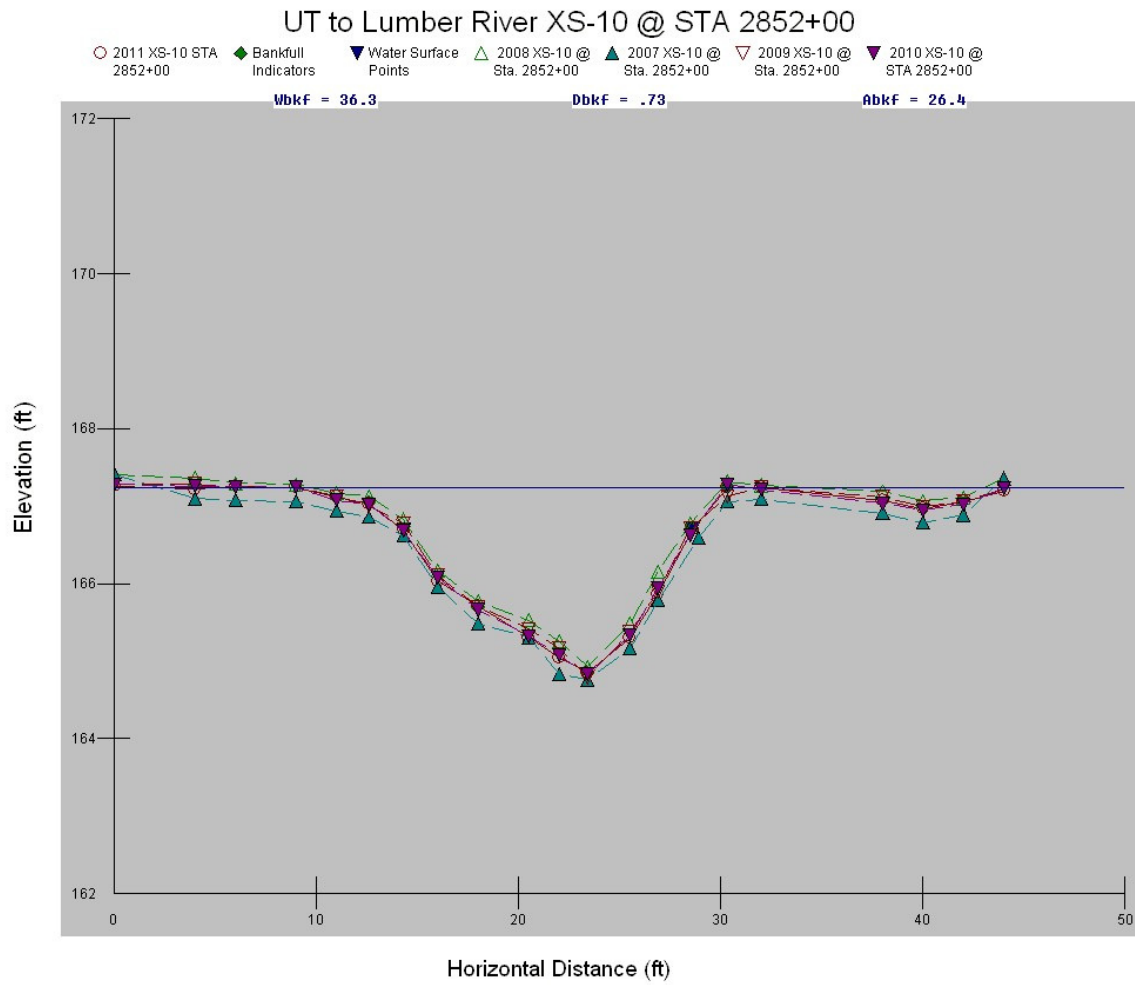
Cross-Section #10 (Pool) Abbreviated Morphological Summary*					
	2008	2009	2010	2011	2012
Bankfull Cross Sectional Area (ft <sup>2</sup> )	23.31	21.96	23.56	24.81	
Maximum Bankfull Depth (ft)	2.37	2.34	2.35	2.39	
Bankfull Mean Depth (ft)	1.1	1.14	1.16	1.16	
Bankfull Width (ft)	21.23	19.3	20.27	21.3

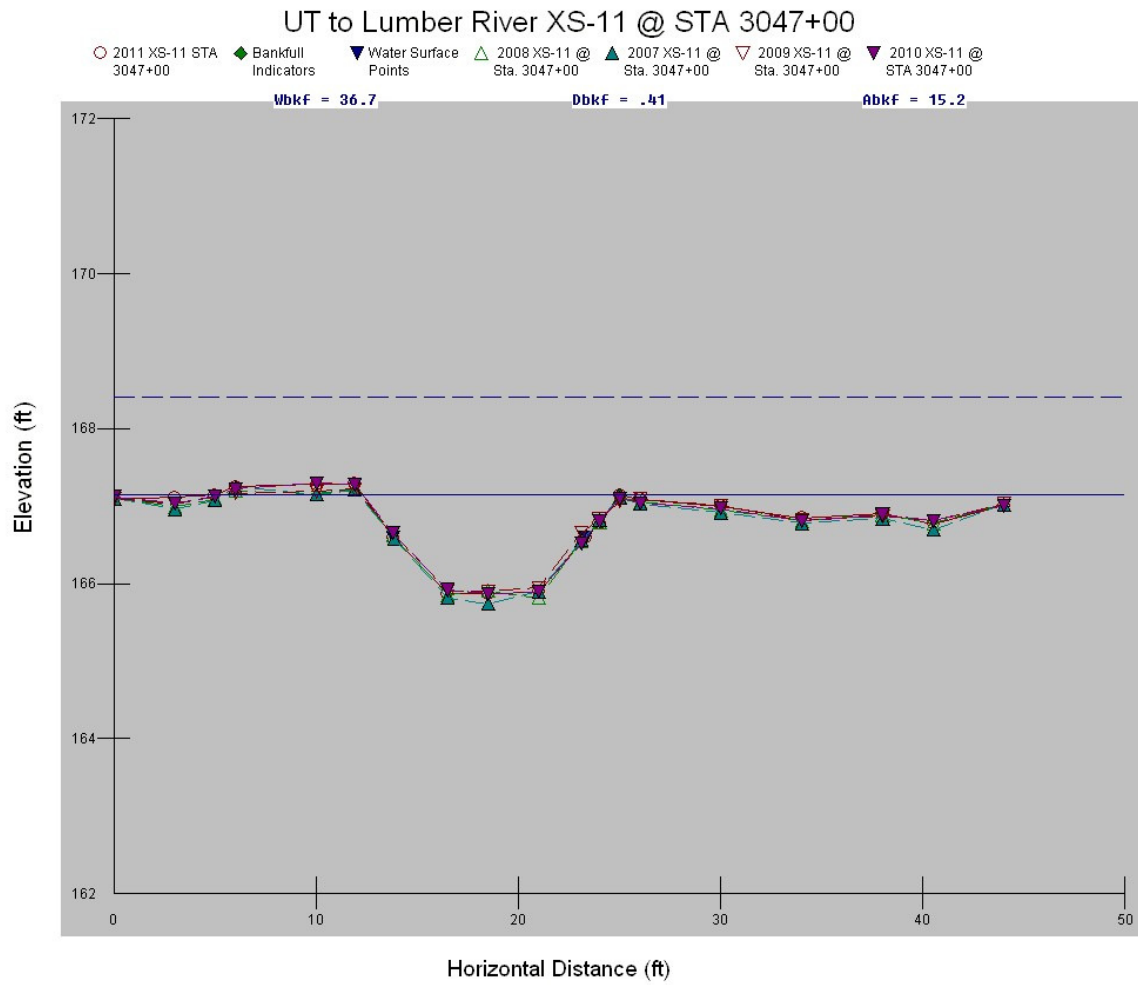
Cross-Section #11 (Riffle) Abbreviated Morphological Summary					
	2008	2009	2010	2011	2012
Bankfull Width (ft)	12.76	12.57	12.56	12.69	
Bankfull Mean Depth (ft)	0.86	0.76	0.83	0.87	
Width/Depth Ratio	14.84	16.54	15.13	14.59	
Bankfull Cross Sectional Area (ft <sup>2</sup> )	10.93	9.54	10.38	11.09	
Maximum Bankfull Depth (ft)	1.3	1.16	1.23	1.27	
Width of the Floodprone Area (ft)	44	44	44	44	
Entrenchment Ratio	3.45	3.50	3.50	3.47

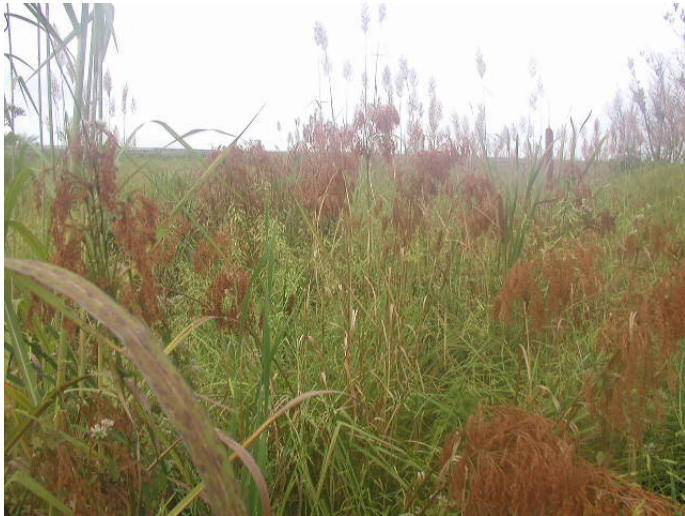
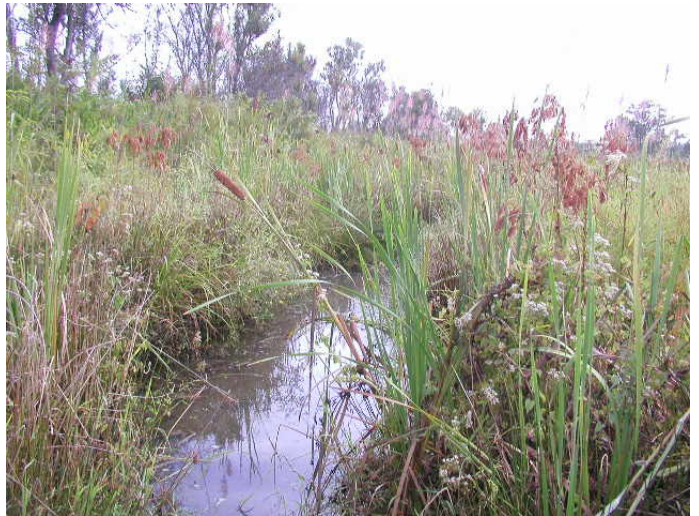
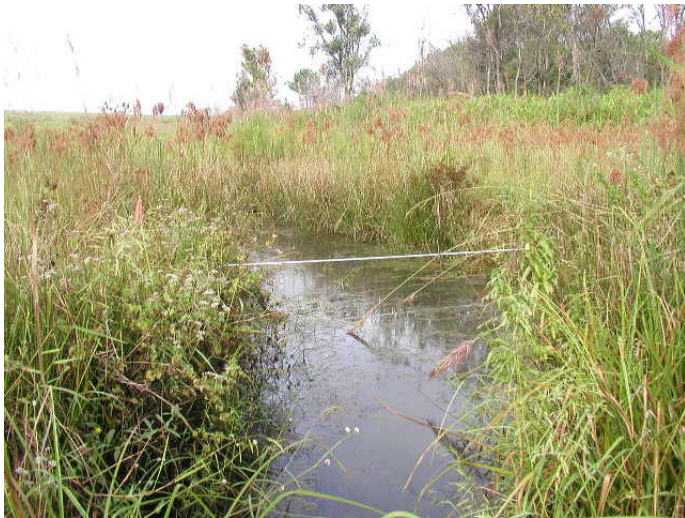
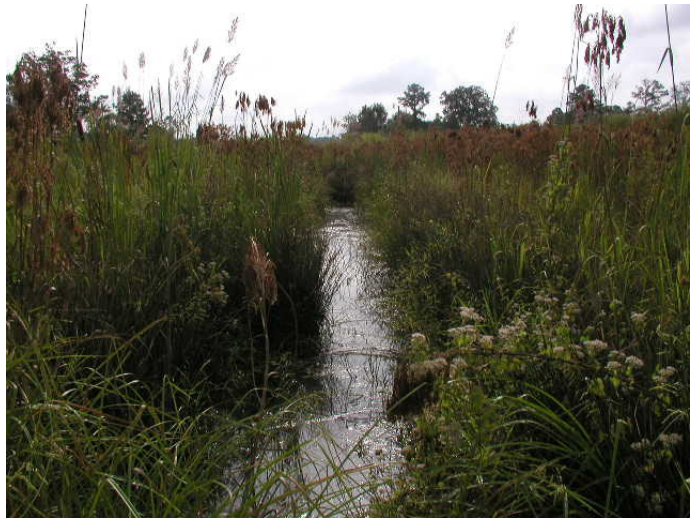
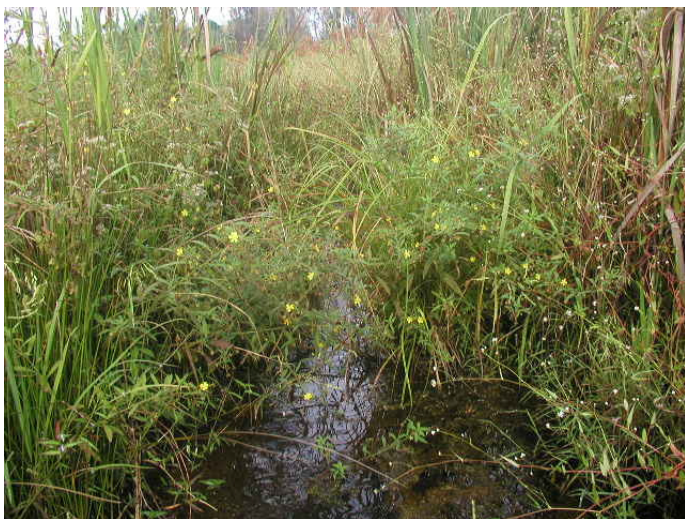
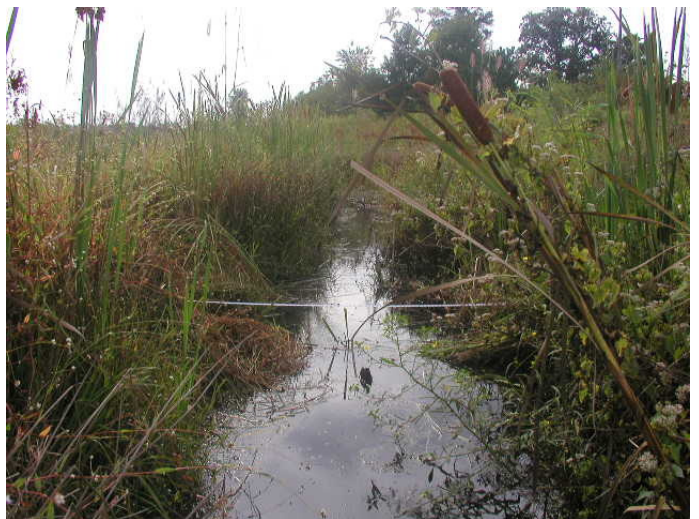
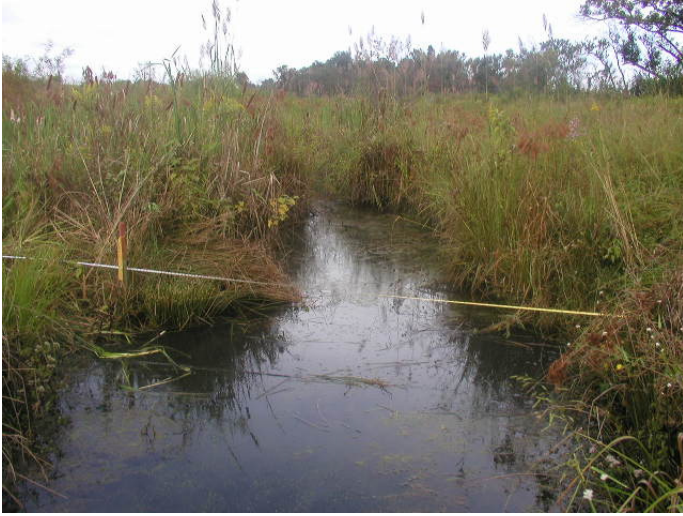
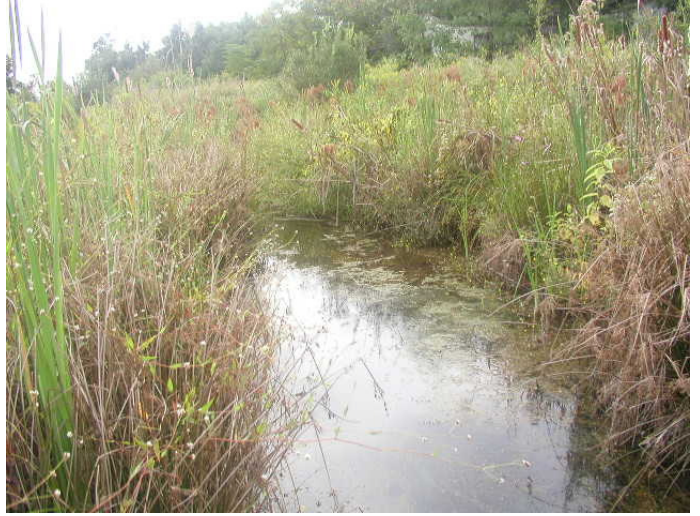
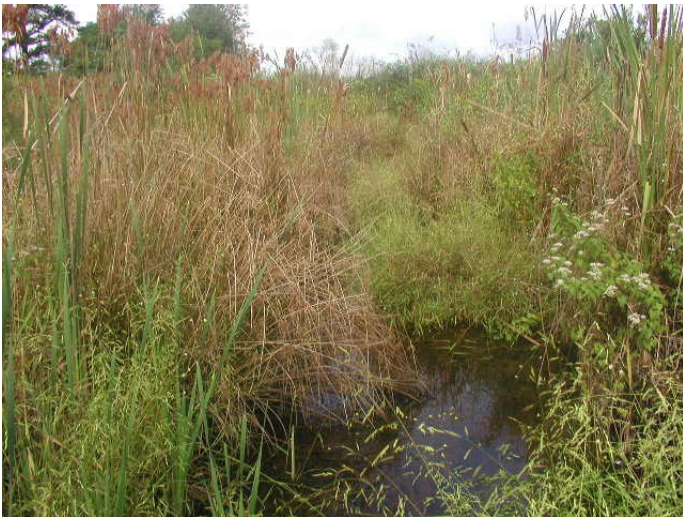
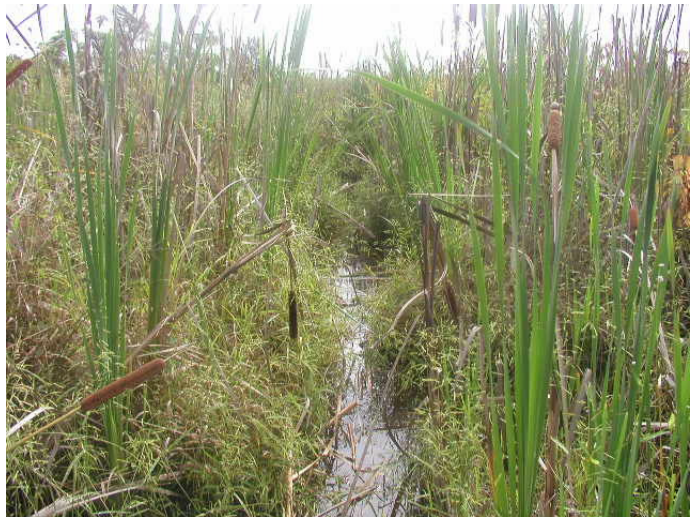
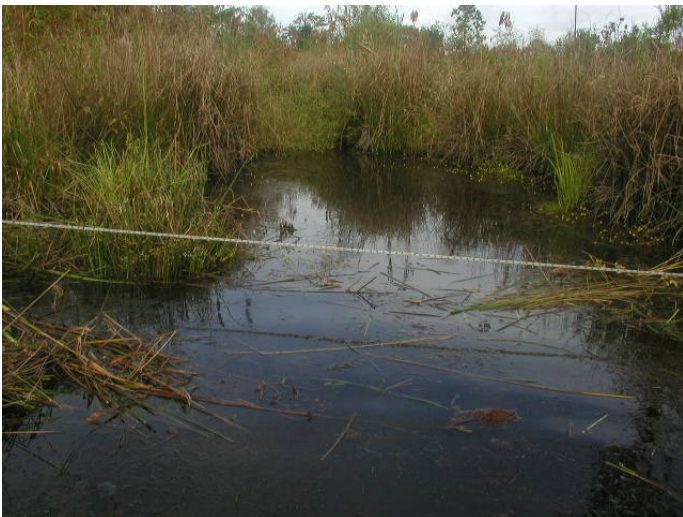
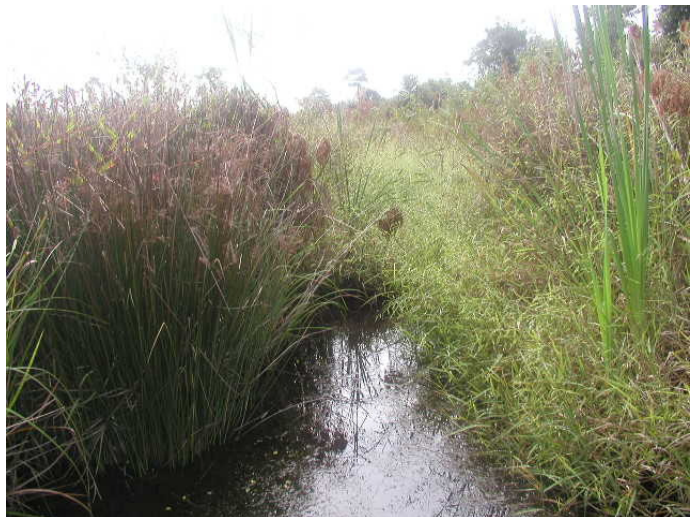
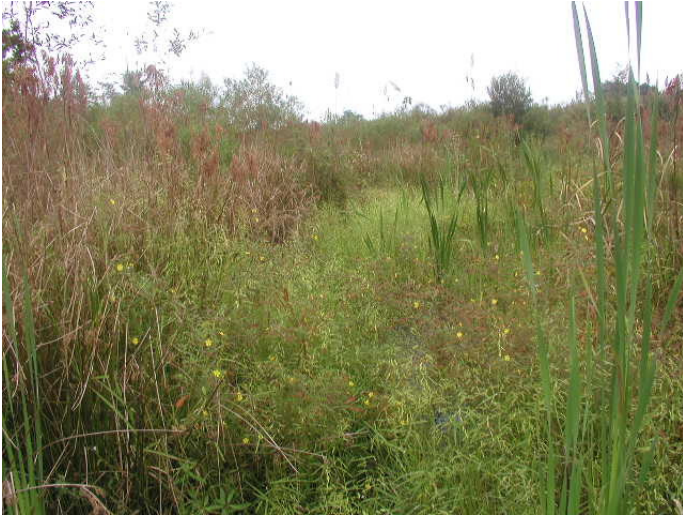
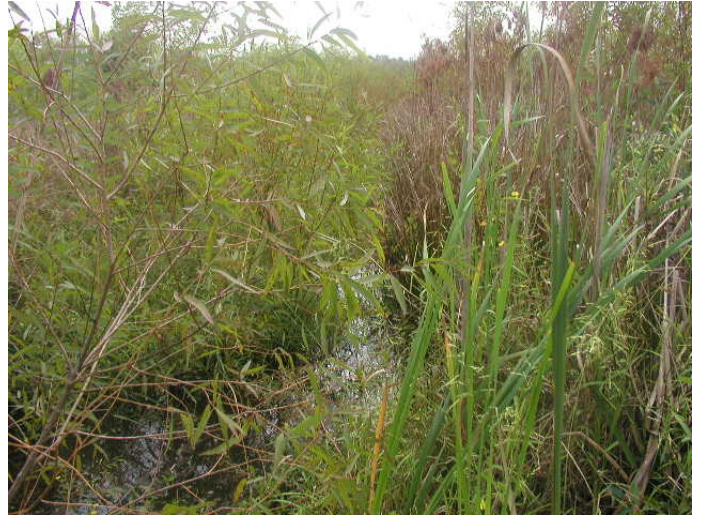
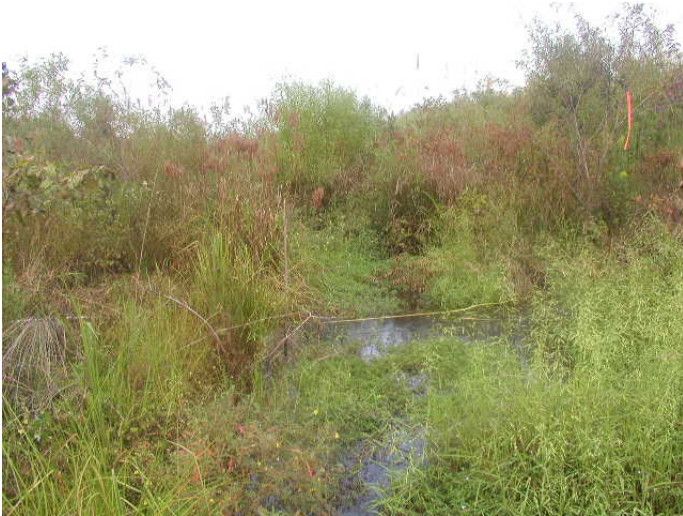
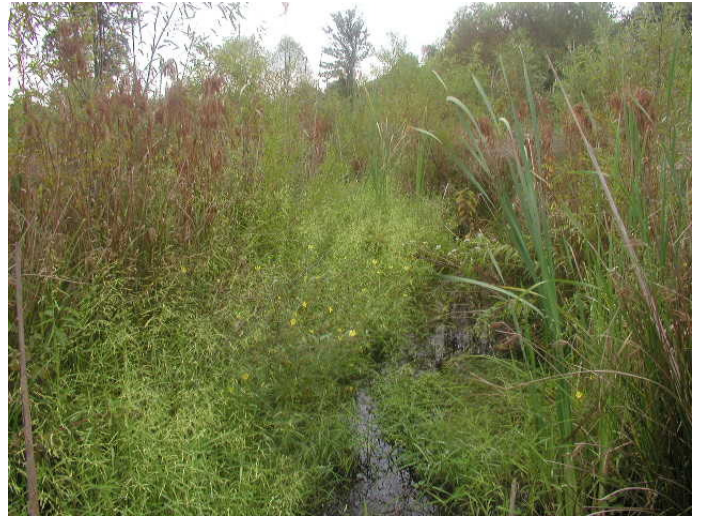
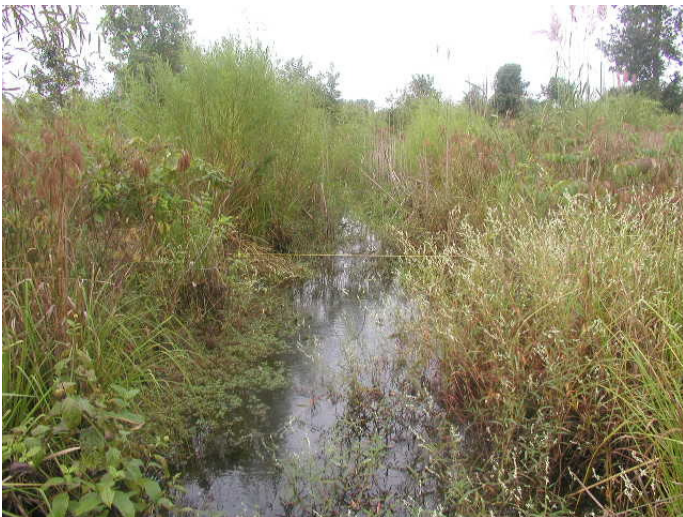
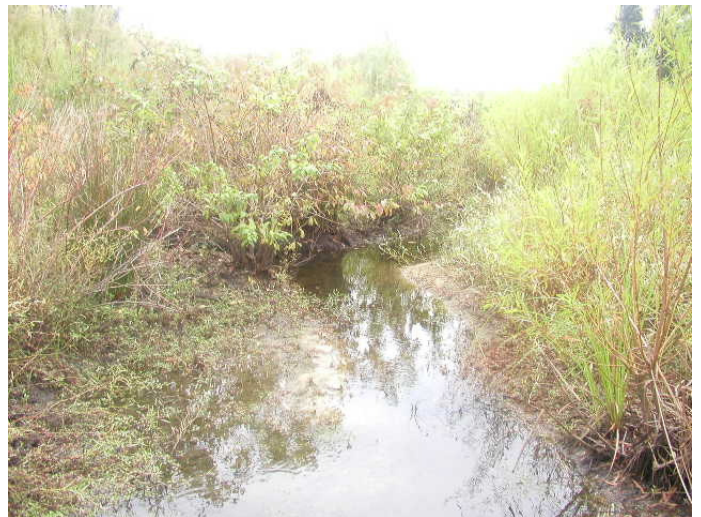
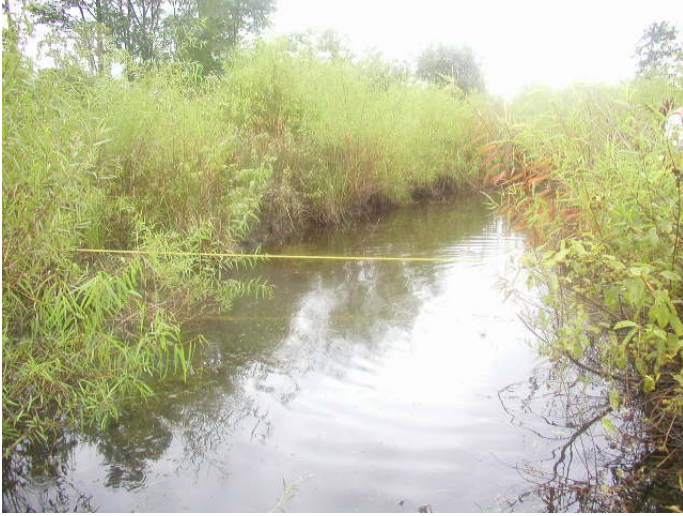
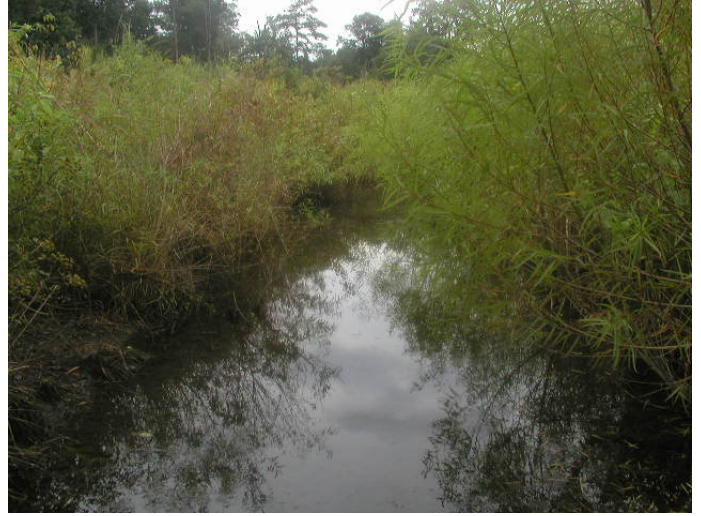
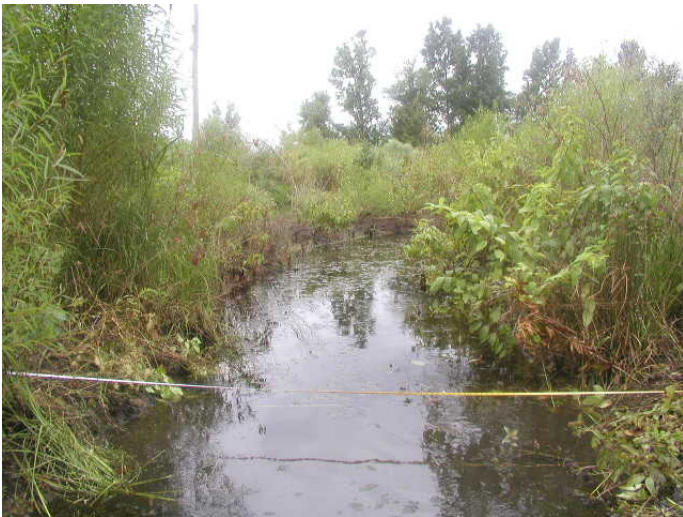
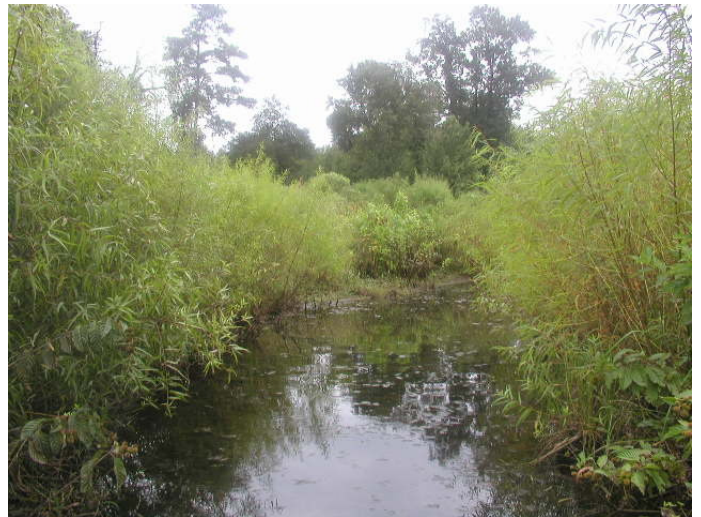
Photo points 1 through 11 showed an extensive growth of herbaceous and woody vegetation. The channel bed is stable throughout the stream restoration project at this time. Beaver dams noted during the 2010 monitoring evaluation were removed and the beavers were trapped by USDA during the 2011 monitoring year.
